TURBINE RESTORED AND PROTECTED WITH BELZONA

Repair of a turbine suffering from corrosion and erosion.

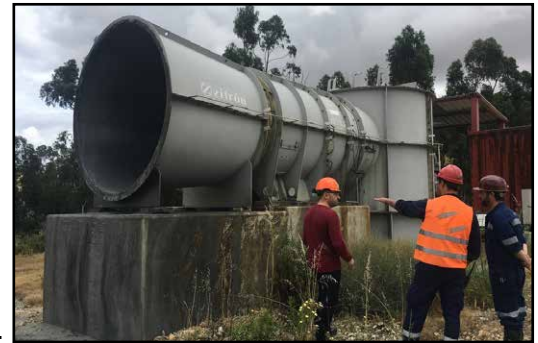
1. Overview of the blower
2. Eroded-corrode turbine
3. Belzona 1331 being applied to the turbine
4. blower back in service

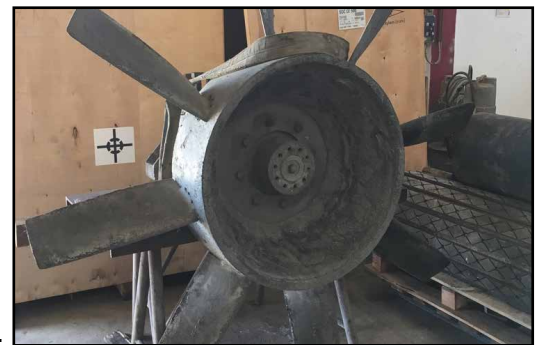
2.

General erosion-corrosion on the turbine of a blower used as part of copper mining process. The erosion had caused a loss of material which could result in balancing issues.

Application carried out in accordance with Belzona Know-How System Leaflet FBC-01 & FBC-02. The turbine was grit blasted down to SA 2.5 and then the lost structure was rebuilt with Belzona 1311. Finally 2 coats of Belzona 1331 were applied to prevent further corrosion-erosion.
