BELZONA KEEPS THE HOSE FLOATING

Surface cuts of floating hoses. The hoses have been brought out of the water into a courtyard for repair due to the damage.

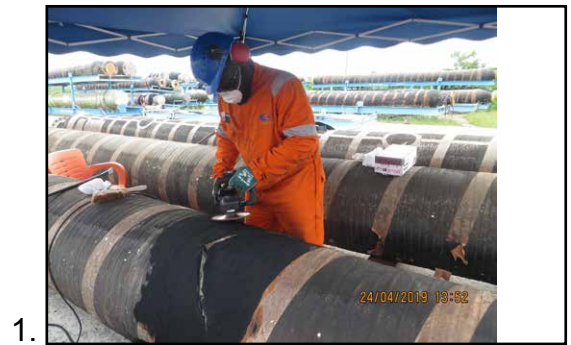
The offloading hose used to carry petroleum products from offshore to shore had cuts caused by debris in the ocean, contact with passing boats and marine life.

1. Damaged Area
2. Surface Preparation
3. Degreasing & removing debris
4. Completed repair
