BELZONA PROTECT NEW WATER DISTRIBUTION PIPEWORK

Water treatment plant, France

New pipework system, 300 m² in total (including 4 large pipework sections, 52 bends and 5 tees)

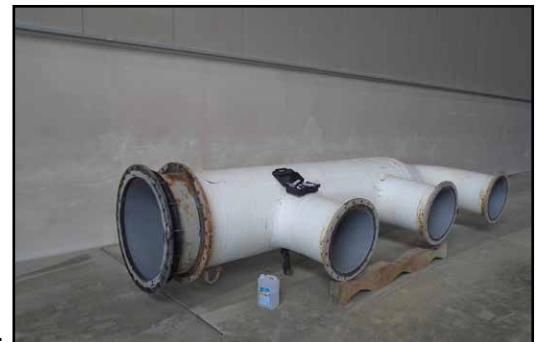
1. Section of pipework (4 in total)
2. Application of Belzona 5821 completed
3. Inspection in progress

Hand application of Belzona 5821 followed by a thorough inspection to ensure that the application was carried out as per the Instructions For Use.
