BELZONA REPAIRS FERTILIZER TANK

Repair of a tank used for fertilizer production.

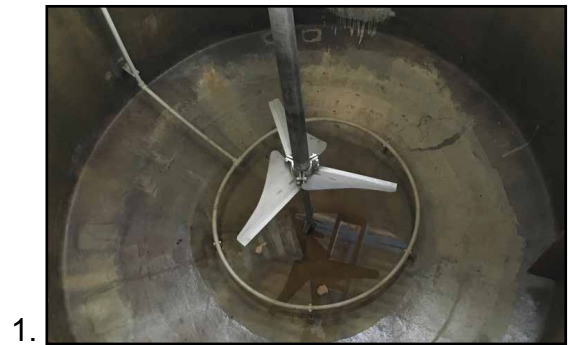
An existing fiberglass lining had failed at the bottom of the tank due to not having the correct chemical resistance for the range of chemical circulating the tank. The failed lining resulted in a loss of material at the base of the tank and also leaving the substrate unprotected and exposed to further chemical attack.

1. Failed fiberglass lining due to chemical attack
2. Rebuilding with Belzona 1111
3. First coat of Belzona 4311
4. Finished application

This application was carried out in accordance with Belzona Know-How System Leaflet TCC-03. The fiberglass coating was removed and the substrate was blasted to SA 2.5 before rebuilding the lost profile with Belzona 1111. Belzona 4911 was used to condition the surface before 2 coats of Belzona 4311 were applied to prevent future chemical attack from occurring.
