## BELZONA BALL MILL TRUNNION REPAIR

Repair of the trunnion section of a grinding mill

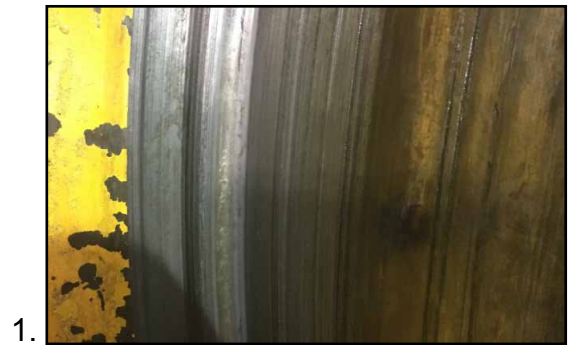
Wear caused over time by the rotating mill grinding against the trunnion section. Also abrasion from the minerals and ores being ground as part of the mining process.

1. Damaged trunnion section
2. Surface preparation using an MBX
3. Applying the Belzona 1121
4. Final application
