## BELZONA PROTECTS RISERS

Offshore gas production platform

Severe sorrosion on gas offshore platform risers

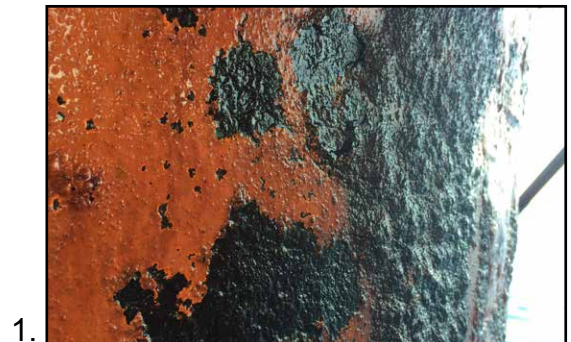
Damage to coating protection led to severe corrosion.

1. Severe corrosion
2. Surface preparation
3. Application in progress
4. Finished aplication
