HIGH CHROME PUMP RESTORED WITH BELZONA

Huelva - Spain

September 2018

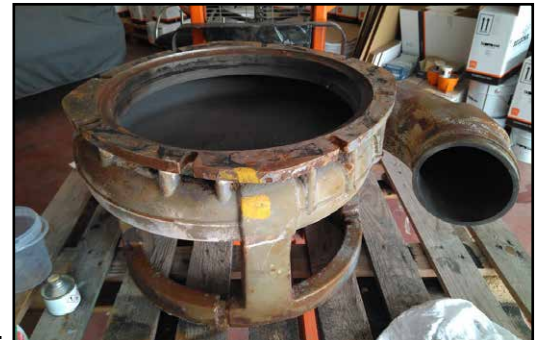
A waste water pump made from a High Chrome Alloy material is used to carry water with a high concentration of suspended solids.

1. General view of equipment
2. Eroded internal casing
3. Belzona 2911 applied
4. Completed application

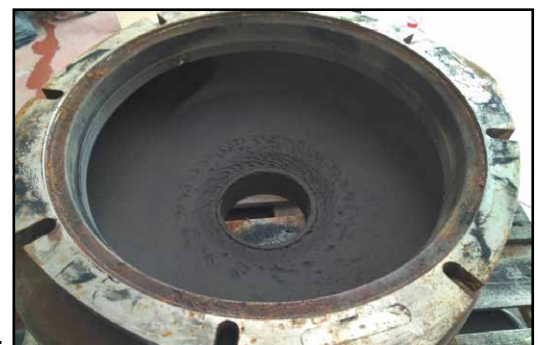
2.

Despite the high hardness of the pump casing material, the high volume of solids in the process fluid has caused entrainment erosion.

The surface was cleaned with water and detergent to remove residues and impurities. A non-ferrous, angular grit was used to grit blast the surface to a near white metal finish, and to achieve a rough profile. Belzona 2911 was applied to the surface and allowed to become touch dry. During the overcoating window, Belzona 2111 was applied. The application was carried out in accordance with a modified version of Belzona Know-How System Leaflet CEP-03.

Belzona 2111 was selected to form a protective barrier for the internal surface from the effects of erosion. The high build nature of the material meant a thick layer could be applied to the surface for extended service life, reducing future maintenance requirements. The Belzona solution was a fraction of the cost of replacement.
