BELZONA ELASTOMER PROTECTS THE HAWSE PIPE ON A YACHT

Protection of a hawse pipe on a yacht using the a Belzona elastomer.

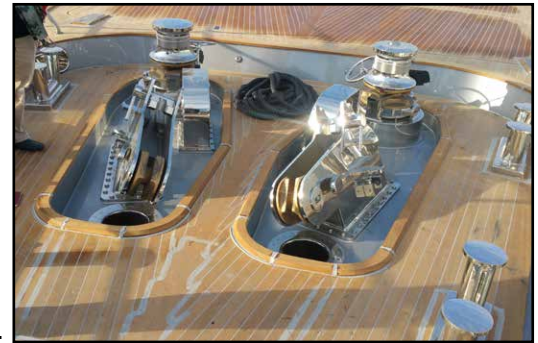
1. View of the application zone
2. View of the external pipe before surface preparation
3. View of the internal hawse pipe after surface preparation with the MBX bristle blaster
4. Finished application with Belzona coatings applied

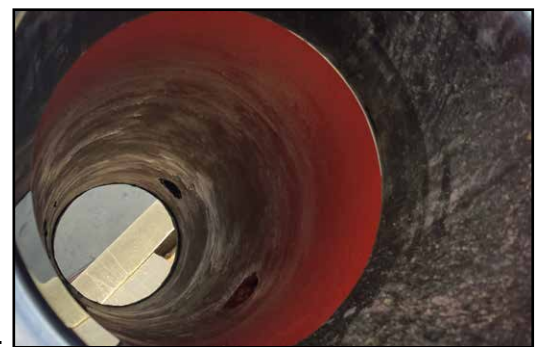
2.

The internal hawse pipe was experiencing corrosion and also wear damage from when the chain would impact against the internal surface of the pipe.
