## BELZONA REJUVENATES STORAGE TANK

Refurbishment of the internal base of a storage tank.

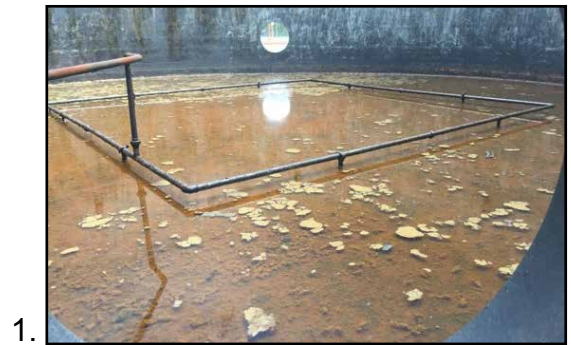
Due to a mixture of water and hydrocarbons the bottom of the tank had started to corroded where the water sits. This is because the density of the water is greater than the hydrocarbons and as the steel is unprotected the tank corroded at the bottom.

1. Before application
2. Grit Blasted surface
3. Coating of Belzona 5811
4. Finished application
