BELZONA PROTECTS HIGH TEMPERATURE OIL TANK

Repair and protection of a glass fiber oil tank.

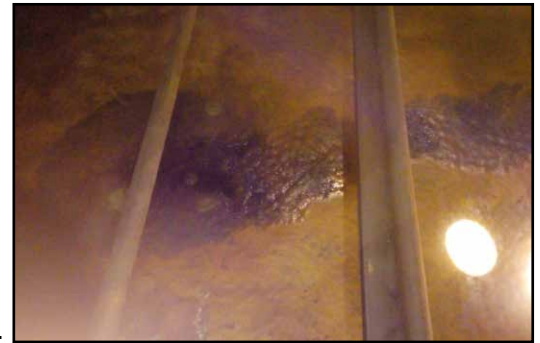
An oil tank operating at 70°C was corroding internally at the base of the tank due to the separation of water and hydrocarbons. The glass fiber tank was also starting to delaminate in areas underneath the heating pipes at the base of the tank.

1. Corrosion and delamination at the base of the tank
2. Belzona 1161 rebuilding
3. Belzona 5892 being applied
4. Finished application
