BELZONA REBUILDS AND PROTECTS A SULPHURIC ACID TANK

Corrosion on the internal side of a storage tank containing sulphuric acid.

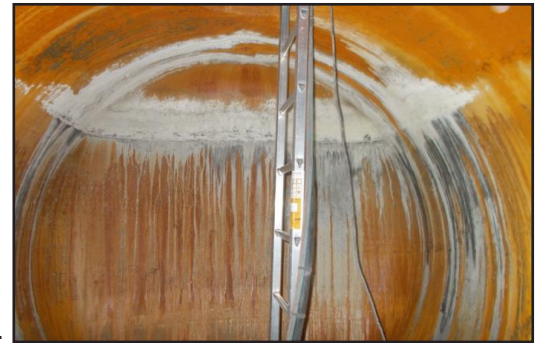
Due to the high concentration of sulphuric acid contained in this storage tank (98%), the walls were severely corroded, causing an unn loss of thickness.

1. Before surface preparation.
2. After surface preparation.
3. Final application.
4. Final application.

The inside of the tank was first grit blasted, then Belzona 1121 was used to recover the loss of thickness. Then Belzona 4311 was used to protect the whole internal surface of the tank against sulphuric acid. This application was carried out in accordance with a modified version of Belzona Know-How System Leaflet TCC-05.
