RECONSTRUCTION OF A CONCRETE TANK IN THE PRE-TREATMENT PLANT USING BELZONA

Reconstruction of defects and chemical protection of the concrete tank in the pre-treatment plant.

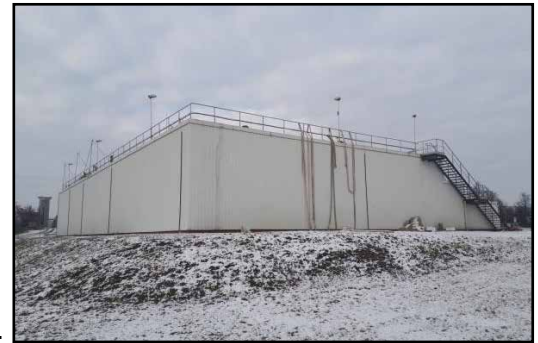
1. Treatment Plant
2. Treatment Plant Problem
3. Treatment Plant Application
4. Treatment Plant Complete with Belzona 4111 & Belzona 4311

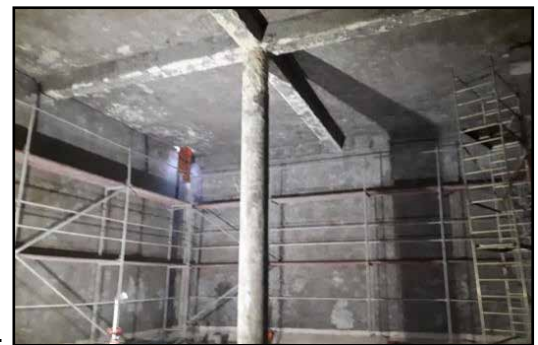
2.

Destruction of the existing chemical resistant coating and significant losses in the tank ceiling beams. Degradation of the coating by chemically aggressive wastewater and their vapors. Cavities and cracks in the concrete walls and ceiling of the tank. Chemical corrosion of concrete resulting in weakening of floor beams.
