## BELZONA SAVES IMPELLER AFTER CHEMICAL EXPOSURE

**CUSTOMER**  
Bristol, UK

**APPLICATION DATE**  
Feb 2019

**APPLICATION SITUATION**  
A circulation pump required its impeller rebuilding after it became worn through accidental acid exposure.

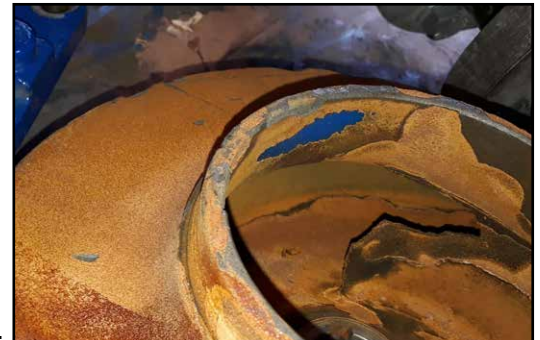
**PROBLEM**  
A pump and impeller were badly damaged by accidental contamination with sulfuric acid at 20% concentration. Lead time for a new unit was 12 weeks, leaving the end user with an expensive period of prolonged downtime. The impeller needed rebuilding to make it operational, and then coating to protect from any further incidental contact.

- PICTURES**
1. Corroded impeller
  2. Close up of interior damage
  3. Profile after grit blasting
  4. Completed repair after coating
