## BELZONA UPGRADES SPIRITS CONTAINMENT AREA

Distillery, Scotland

Spirit containment area/bund became damaged over time.

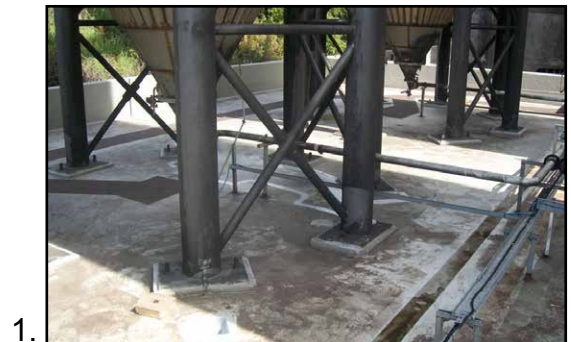
The existing protective system had failed. The chemical containment area could no longer be relied upon to prevent liquid loss into the groundwater/watercourse in the event of a spillage.

1. Containment area prior to Belzona Application
2. Application of Belzona 5811 underway
3. Completed Application
4. Area revisited in 2019

Application was carried out in accordance with Belzona Know-How System Leaflet TCC-15. Belzona 4131 and Belzona 4141 were used to repair the degraded sections of the walls and to create fillets to all horizontal and vertical corners of the bund. The floor was screeded with Belzona 4131 at 6mm to provide maximum impact resistance. A two coat system of Belzona 5811 was then applied to all the internal surfaces of the bund.
