## BELZONA PROVIDES UNCONVENTIONAL TANK BASE SEALING

Chemical Company, Warrington

October 2019

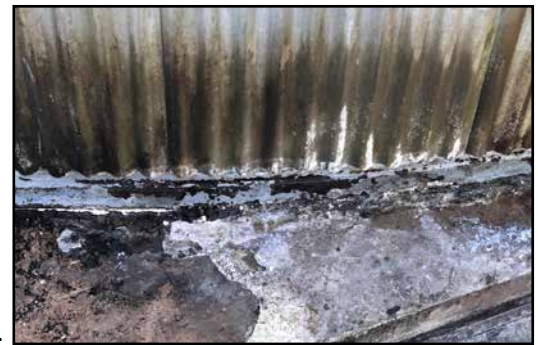
The problem was leakage of product under the base plate in trickles suggesting there is a pinhole in the steel annular plate. It was nearly impossible to remove the hardened product and consequently the location of the pinhole is impossible to locate.

1. Showing annular plate / concrete plinth leakage and corrosion
2. Shows solidified product in the base of the tank
3. Application of conditioners
4. Completed application

The steel annular plate was abraded manually to give a rough finish, and the concrete receive the same treatment to remove any debris and contamination. Belzona 2911 was applied between the base plate and plinth and allowed to dry. Belzona 2211 was applied into the gap to provide a seal and prevent further product leakage. Belzona 3921 and Belzona 3931 were applied to condition the annular plate, followed by two coats of Belzona 3131 to finish. The application was completed in accordance with Belzona Know-How System Leaflet GSS-3.

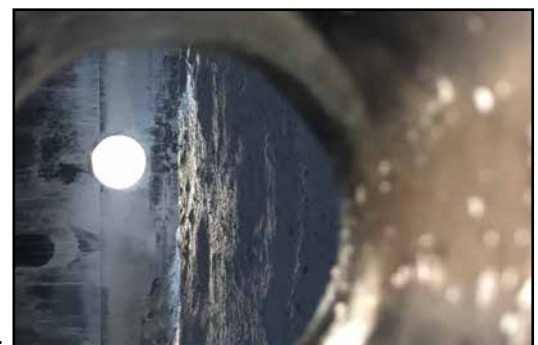
2.

Old storage tank being brought back into service due to client demands, the company needed to refurbish the tanks with health & safety in mind. The tanks hold neutral sodium silicate and the old product has solidified in the bottom of the tank, removal was not cost effective.
