## BELZONA SEALS SILO FLANGE

Power Plant, Liverpool, UK

November 2019

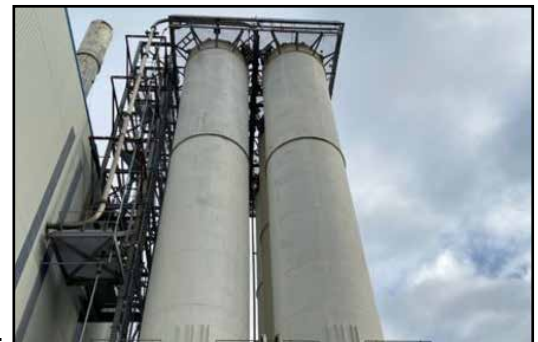
Dry powder silo had mastic sealant between flange joints which hardened and shrunk. This resulted in the mastic falling out leaving exposed gaps. The silo is tall and difficult to reach so using a specialist rope access contractor was the best option.

Mastic joint sealants are not bonded to the inside of the joint. As a result, when they shrink the sealant falls out, leaving a void for water and pollutant penetration into the dry powder.

1. Silo showing the suspect flange joint
2. Leaking flange joint
3. Rope access contractor applying Belzona materials
4. Completed application on powder silo
