BELZONA 1111 & BELZONA 4311 RECONSTRUCTS AND PROTECTS CHEMICAL PUMP

APPLICATION SITUATION
KSB centrifugal pump which is used for pumping chemicals, in a sugar factory.

PROBLEM
The chemicals attacked or completely destroyed the flange surfaces and parts of the housing.

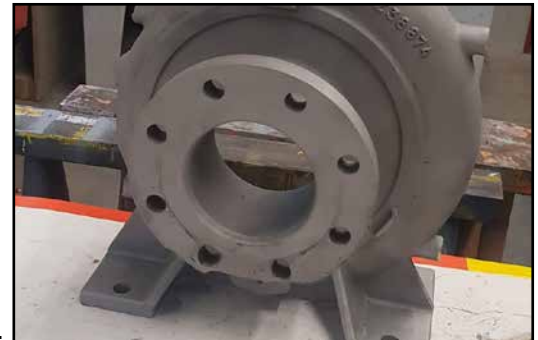
1. Damaged pump
2. Flange reform
3. Internal coating complete
4. Flange reformed.
