## BELZONA 5721 LEP SOLUTION WIND FARMS

Wind Farm, Minnesota

Sep 2019

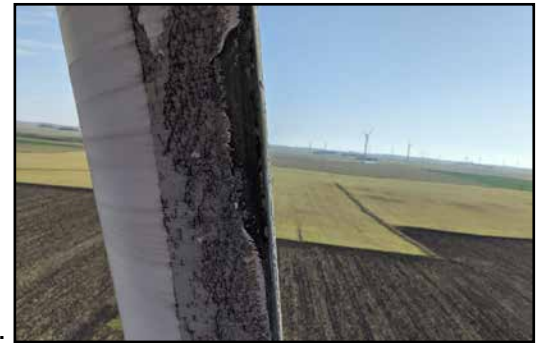
Over time, the leading edge of wind turbine blades become eroded and lose efficiency and power production for the turbine generator. Because of the time of year, the weather was very cold, and a blade repair solution was needed to properly complete the repairs.

1. Damaged leading edge of wind blade
2. Belzona 5721 ready to mix
3. Finished Belzona 5721 application on leading edge
4. View of the Wind Farm

The application was carried out in accordance with a modified version of Belzona Know-How System Leaflet FBC-1. The blades were coated on the turbine at the operation site. The pitting and loss of surface on the leading edge was resurfaced with a filler product and rebuilt to dimensions. The surface area was sanded down with a mechanical sander and cleaned with a rag and non-residual solvent cleaner. One coat of Belzona 5721 at 20 mils (508µm) was applied.
