BELZONA PROTECTS TANK ROOF AGAINST SULPHUR FUMES

Repair of a Sulphur tank roof used as part of an oil refining process.

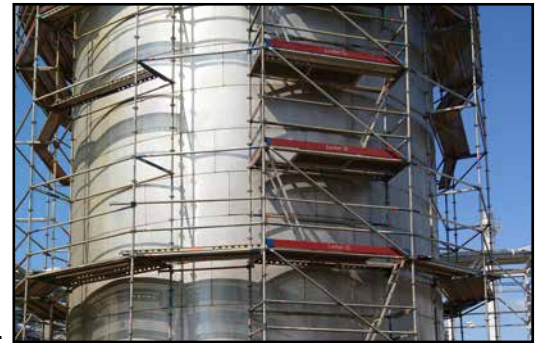
1. Outside view of the Sulphur tank
2. Corroded tank roof
3. Two coat system of Belzona 1593 applied to the roof
4. View of the tank roof from the bottom

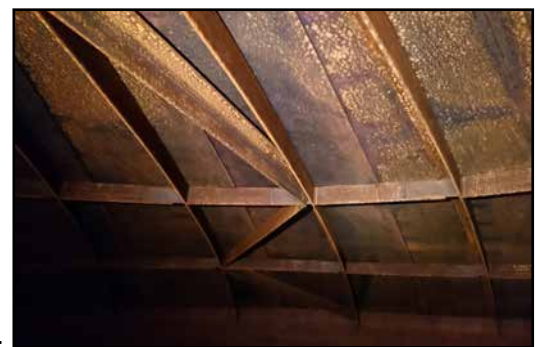
2.

A build-up of condensation from the sulphuric acid had caused the tank roof to pit and corrode.

This application was carried out in accordance with Belzona system leaflet TCC-05. The tank roof was cleaned and then grit blasted to SA 2.5, achieving a 75 micron profile to provide an excellent level of adhesion to the substrate. Once grit blasted, any pits were filled in with Belzona 1511 before two coats of Belzona 1593 were applied to the tank roof.
