BELZONA 4111 STANDS UP TO HEAVY MINE TRAFFIC

Mine site wash bay with a concrete floor.

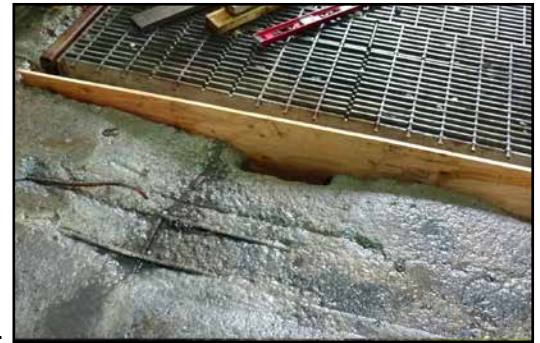
Extremely deep wear in the concrete floor in the tread areas of this wash bay. Full mine haul trucks roll across this floor year round with cleated tire chains. The deep ruts were being covered with heavy steel plates. Both the ruts and steel plates were causing a hazard to the crew when walking in the area.

1. Original wear and one of the the mining trucks causing the damage
2. Belzona 4111 applied May 2016
3. Belzona 4111 in April 2016
4. Belzona 4111 in November 2019

A grinder and wire wheel was used to remove all the loose material from the surface of the area of application. The exposed steel re-bar was prepped with the grinder to remove all rust and corrosion. Belzona 4911 conditioner was then applied over the area, and immediately following the Belzona 4111 was applied and finished with a steel trowel.

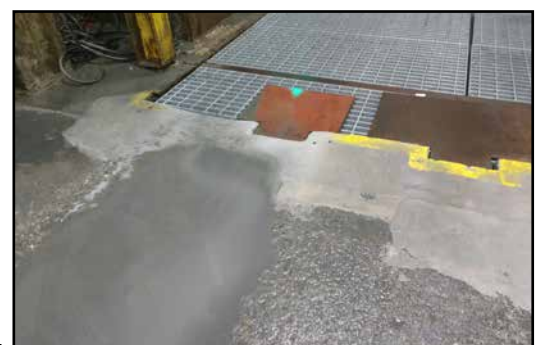
Replacing the floor was not an option as it would require the entire mine to shut down for 28 days while the concrete cured. The mine had a 3 day maintenance shut down planned, and the repair had to be done during this time, and be ready for use at the end of the shut down with no exceptions. Using Belzona 4111 allowed for the application to be done on the first day of the shut down, and was fully cured and ready for operation 3 days later. Pictures 1 and 3 years later show extremely minimal wear, and should any further repairs be needed, applying more 4111 over the top will also be fast and can be done during a scheduled shut down. The mining operation is now planning on using Belzona 4111 in several other areas of their operation as the material has proven it's suitability for this highly aggressive environment.
