BELZONA 4111 STANDS UP TO HEAVY MINE TRAFFIC

Alaska

Mine site wash bay with a concrete floor.

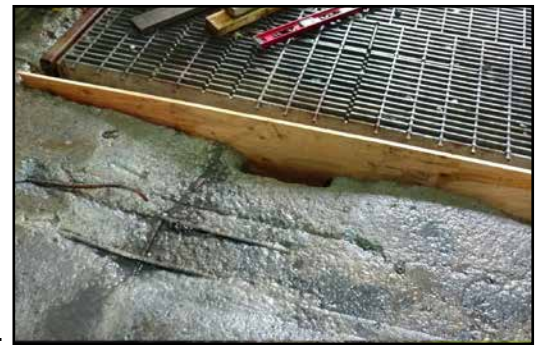
Extremely deep wear in the concrete floor in the tread areas of this wash bay. Full mine haul trucks roll across this floor year round with cleated tire chains. The deep ruts were being covered with heavy steel plates. Both the ruts and steel plates were causing a hazard to the crew when walking in the area.

1. Original wear and one of the the mining trucks causing the damage
2. Belzona 4111 applied May 2016
3. Belzona 4111 in April 2017
4. Belzona 4111 in November 2019

A grinder and wire wheel was used to remove all the loose material from the surface of the area of application. The exposed steel re-bar was prepped with the grinder to remove all rust and corrosion. Belzona 4911 conditioner was then applied over the area, and immediately following the Belzona 4111 was applied and finished with a steel trowel.

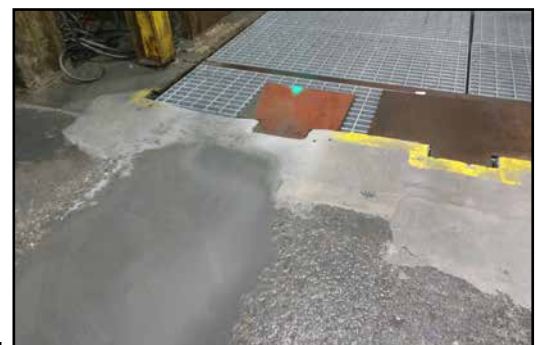
Replacing the floor was not an option as it would require the entire mine to shut down for 28 days while the concrete cured. The mine had a 3 day maintenance shut down planned, and the repair had to be done during this time, and be ready for use at the end of the shut down with no exceptions. Using Belzona 4111 allowed for the application to be done on the first day of the shut down, and was fully cured and ready for operation 3 days later. Pictures 1 and 3 years later show extremely minimal wear, and should any further repairs be needed, applying more 4111 over the top will also be fast and can be done during a scheduled shut down. The mining operation is now planning on using Belzona 4111 in several other areas of their operation as the material has proven it's suitability for this highly aggressive environment.
