BELZONA REPAIRS EXPANSION BELLOW AT A POWER PLANT

APPLICATION SITUATION
Expansion Bellows at a large fossil fuel-fired power plant.

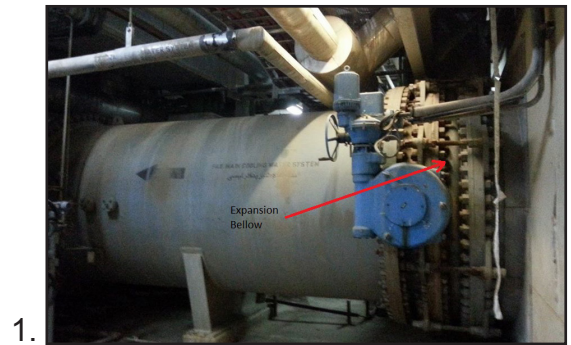
PROBLEM
The expansion bellows were in critical condition where layers of the rubber were disbonded and accumulating. These were blocking the tubes at inlet section of the condenser and ultimately reducing its efficiency.

1. Expansion bellows in operation.
2. The bellows prepared for the repair.
3. The application of Belzona 2211.
4. Repaired bellows.
