BELZONA KEEPS A FLOATING HOSE AFLOAT

A floating hose.

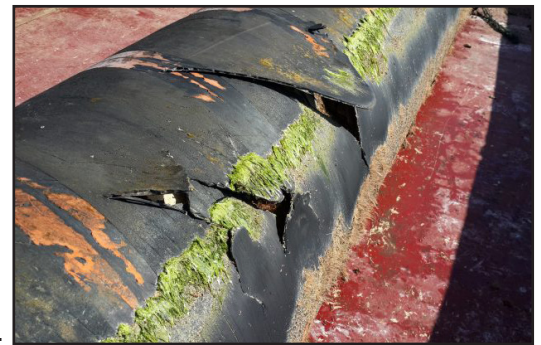
A floating hose got severely damaged due to a collision with a ship's propeller

1. Damaged hose before the application.
2. Application of Belzona 2211.
3. Use of Belzona 9341 (Reinforcement Sheet).
4. Complete application.
