## BELZONA SEALS LEAK IN UNDERWATER OBSERVATION WINDOW

A leak on the underwater window.

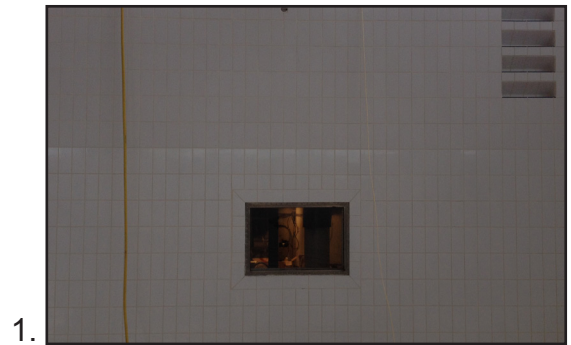
1. View of observation window
2. Metal surface prepared
3. Perimeter of the window masked off
4. Completed application with all tapes removed
