## BELZONA REPAIR AND PROTECTION OF INTERNAL SURFACE OF WIL TRAY MACHINE

Repair and protection of internal surface of wil tray machine 1.6 meters in width by 16 meters in length.

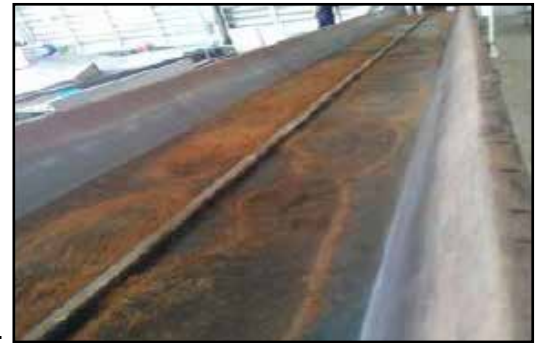
Corrosion at internal surface of wil tray machine.

1. Corrosion found at internal surface of wil tray machine.
2. Application of first coat of Belzona 5892
3. Repair of pitting damage area with Belzona 1121
4. Application of second coat of Belzona 5892
