## BELZONA REPAIR AND LINING OF MULTIMEDIA FILTER TANK AND ACTIVATED CARBON TANK.

Lining of a 2.2 meter diameter by 1.5 meter high multimedia filter tank and a 1.2 meter diameter by 1.5 meter high activated carbon tank.

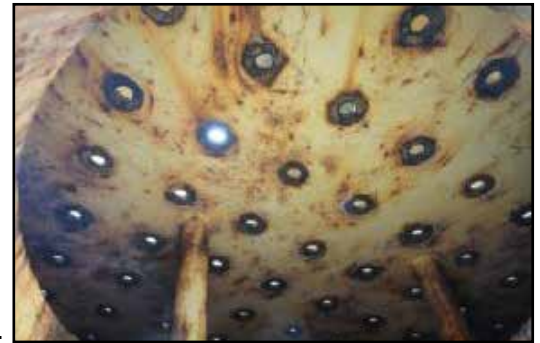
Corrosion found at internal surface of multimedia filter tank

1. Corrosion at internal surface of multimedia filter tank
2. Corrosion at internal surface of activated carbon filter tank
3. Repair of pitting damage area with Belzona 1121
4. Application of second coat of Belzona 5811
