BELZONA STOPS COOLING TOWER LEAKS

Independent Power Plant in South Texas, USA

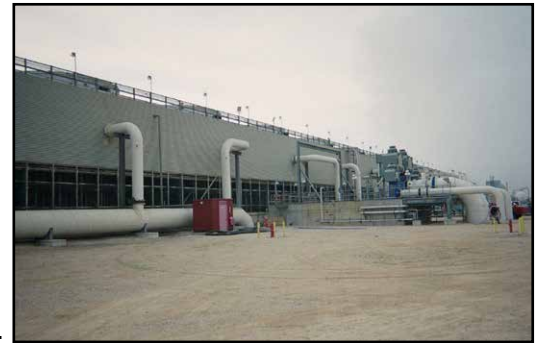
1. Large Cooling Tower
2. Joint blasted and backer installed
3. Belzona 2221 being poured into joint
4. Finished repair. Joint holds back rainwater.
