## BELZONA EXPANDS THE LIFE OF EXPANSION JOINTS

On-shore GOSP, Saudi Arabia

34 inch expansion joints on a 25-year-old pipeline

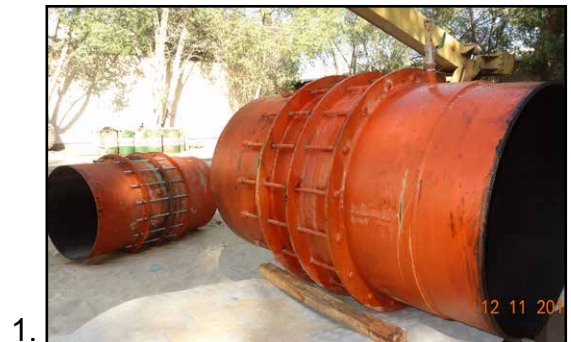
1. The expansion joints taken out of operation
2. The damage before
3. Application in progress
4. Completed application
