BELZONA REPAIRS A VACUUM PUMP CASING AND PROTECTS IT AGAINST CAVITATION

Part of a casing on a vacuum pump

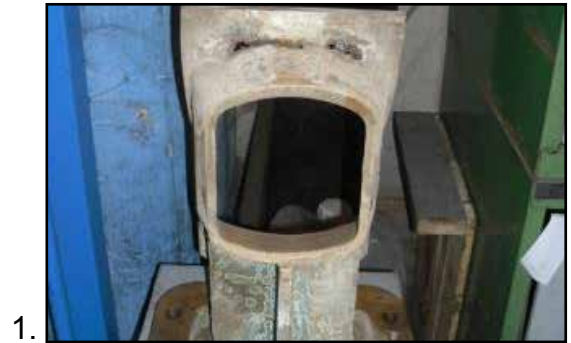
1. Overview of the equipment
2. Close-up view of the damage
3. Final application

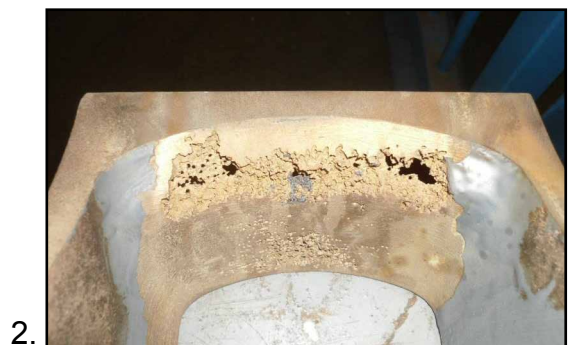
The casing of this pump was exposed to a severe cavitation causing important damages and perforations after only a few months.

Application was carried out using a modified version of Belzona Know-How System Leaflet CEP-7. Belzona 2311 was first used to rebuild the damaged area, then Belzona 2141 was used to protect the whole application against cavitation.
