## BELZONA EXTENDS THE LIFE OF A CRF WHEEL

Blades on a CRF wheel in a nuclear power plant.

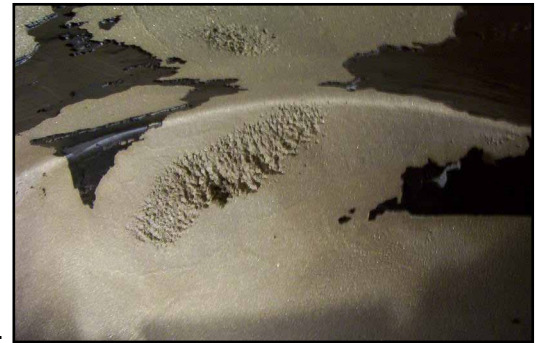
The coating and the equipment were damaged by cavitation.

1. Before application
2. After application

Application was carried out in accordance with Belzona Know-How System Leaflet CEP-05. After the removal of the remaining patches of the previous coating, the substrate was rebuilt using Belzona 2311. Belzona 2141 was then used to protect the area against cavitation.
