## BELZONA REPAIRS DAMAGED PRE-HEATER FAN SHAFT

Egypt

2008

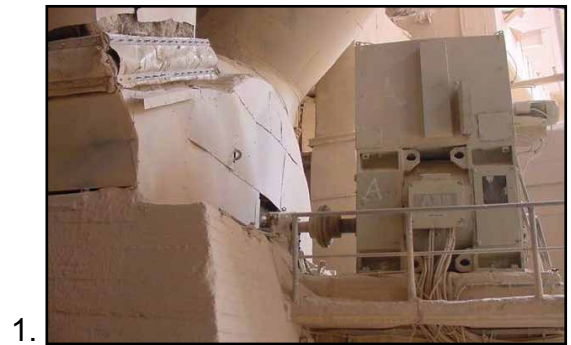
The shaft was worn out under the bearing.

1. The damaged equipment
2. The damaged area
3. The application before removal of formers
4. The completed application

This application was carried out in accordance with MPT-2. The shaft can be returned to its original dimensions by using released split formers. These can easily be removed once the product has cured to reveal a perfect finish.
