## ROOF PENETRATION PROBLEM SOLVED WITH BELZONA

**APPLICATION SITUATION**  
20 year roof of a chemical manufacturer

**PROBLEM**  
An extraction vent had created a leak at its penetration which could create a slip problem in the factory below

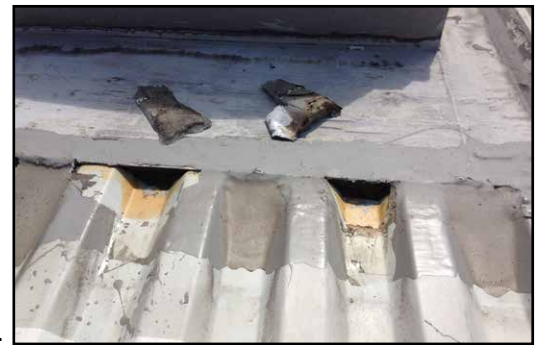
- PICTURES**
1. Problem area
  2. Belzona elastomer used to prevent standing water
  3. Completed repair
  4. Completed repair

**APPLICATION METHOD**  
The application was carried out in accordance with RPA-1. The problem had been made worse by standing water in the troughs, which had caused the existing seal to have to work harder. The Belzona Consultant included as part of the repair, the use of Belzona elastomers (due to the flexing of the roof) to allow the water to shed effectively.
