REPAIR OF SEA WATER INLET VALVE WITH BELZONA

Shipyards, ISTANBUL, TURKEY

Ship sea water inlet valves.

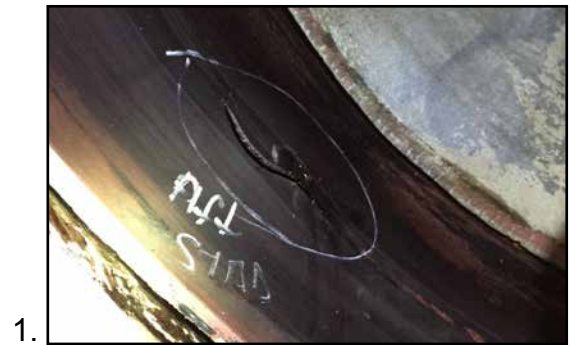
Sea water inlet valve sealing rubber surface has been damaged. Valve is not sealing properly.

1. Damaged surface of the valve
2. After surface preparation
3. Application of Belzona 2911
4. Application of Belzona 2211

Application was carried out in accordance with Belzona Know-How System Leaflet VPF-03. Damaged rubber surface was undercut and abraded to achieve a mechanical bond. The surface was conditioned with Belzona 2911 and allowed the cure. Then Belzona 2211 was applied and allowed to cure.
