## BELZONA PROVIDES INTERNAL CORROSION PROTECTION FOR GRAVITY SEPARATORS

Natural Gas Purification Plant in Southwest China

Natural gas plant raw material gravity separator.

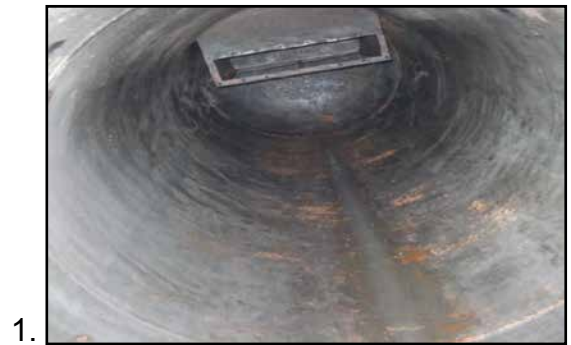
The base and top of the separator have been subjected to erosion and corrosion for a long time, and a large amount of pitting corrosion has emerged.

1. Separator inner wall before application
2. Inner coating completed
3. Coating integrity reviewed in 2010
4. Coating thickness reviewed in 2015

Application carried out in accordance with Belzona Know-How System Leaflet TCC-5. Belzona 1111 to repair the pitting defects and then apply Belzona 1321 to complete the application.
