BELZONA PROTECTS A FLOOR OF A LEADING EUROPEAN COMPANY.

CUSTOMER
Switzerland

APPLICATION DATE
2019

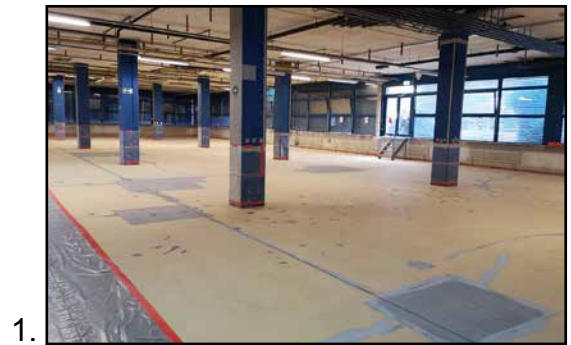
1. Floor Preparation
2. Airless Spraying of Belzona 5811
3. Close up of incorporated aggregate
4. Complete Job

The concrete substrate was abraded to expose the aggregate, the surface was sprayed with Belzona 5811 using airless spraying equipment in accordance with Belzona System Leaflet FPA-3. The expansion joints were filled using Belzona 4521 in accordance with Belzona System Leaflet FPA-6
