BELZONA 1381 TANK PROTECTION

This customer uses 3 tanks with a fluid flow mix. 2 tanks are bigger, last one is smaller.

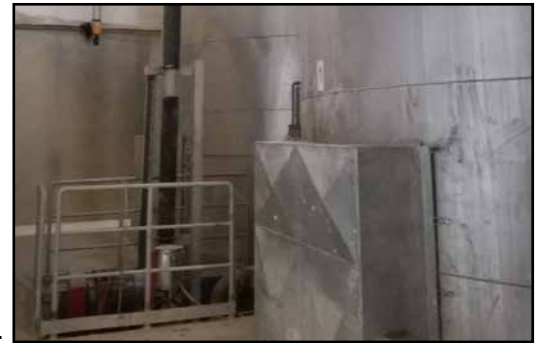
1. Two tanks are bigger
2. Fluid flow mix
3. Tank was blasted and cleaned
4. Second layer of Belzona 1381
