TUBE SHEET ENGINE COOLING EXCHANGER PROTECTION WITH BELZONA

Nuclear electric power plant in Slovakia.

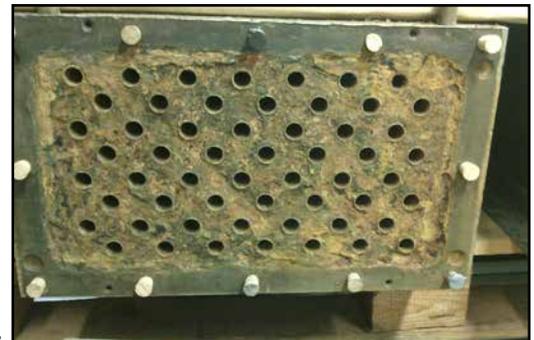
1.

These strong acids even if they are diluted cause big corrosion.

PICTURES
