BELZONA 1251 PREVENTS MAJOR PLANT SHUTDOWN

400NB Spool on the client's Cyclone Feed Line with an operating temperature of 80 °C running Caustic Slurry. The pipeline in question is critical to the client, if it failed, it would mean the plant would be at half capacity.

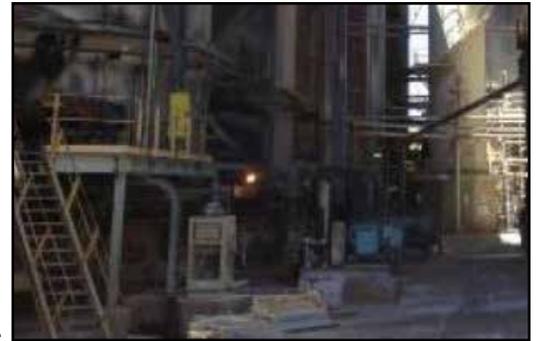
1. Spool location
2. Spool condition prior to repair
3. Repair using 1251 and 9341
4. Repair using 1251 and 9341

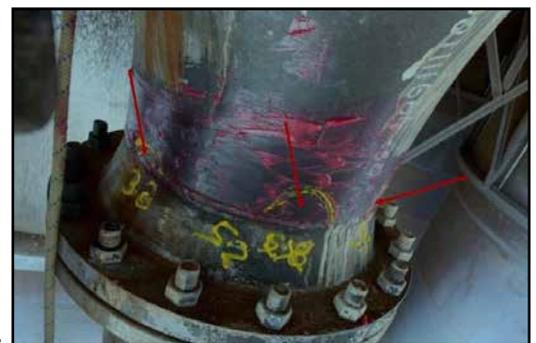
2.

The original wall thickness was 9.56(mm) The current thickness is around 3mm in different spots and unable to UT the weld before the neck. This is on live equipment and due to the location of the spool rope access was required.
