BELZONA REPAIRS LEAKING ROOF AT UNIVERSITY

University Campus, North Wales

University canteen roof.

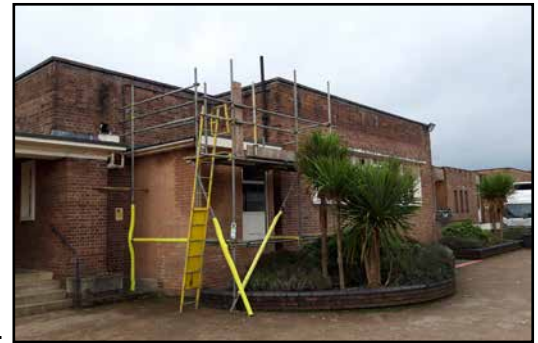
A small felt roof over a section of the canteen was in need of repair. The felt system had degraded to the point where rainwater is now entering the building.

1. University canteen roof ready for repair
2. Surface preparation in progress
3. Application of Belzona 3131 in progress
4. Completed application
