BELZONA REBUILDS CRACKED WATER CHANNELS AT OUTDOOR POOL

The water channel at outdoor pool.

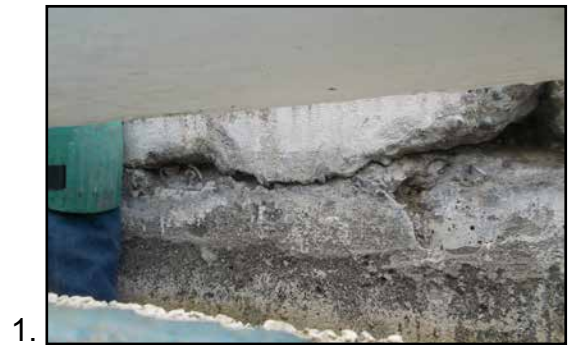
The pool gutter system had developed major cracks in various areas allowing water to escape.

1. Extent of cracks needing rebuilding
2. Surface preparation underway using a hand grinder to clean and remove all loose material
3. A completed section of repair
4. Completed application
