BELZONA HELPS IN THE PROTECTION OF A SURFACE UNDER THE GRANULE SCRAPER.

Puławy, Poland

Modernisation and protection of the surface area under the granule scraper.

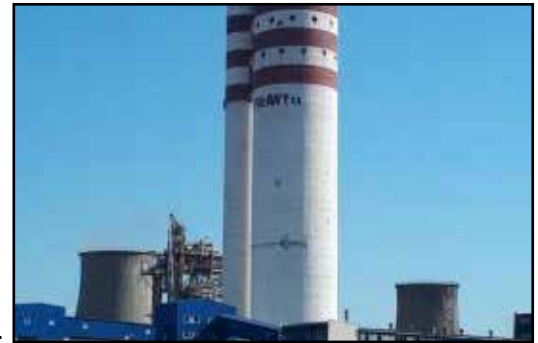
1. Application Area Picture
2. Area to be treated under the scraper
3. Applying Belzona 4151 & Belzona 5811
4. Application Completed

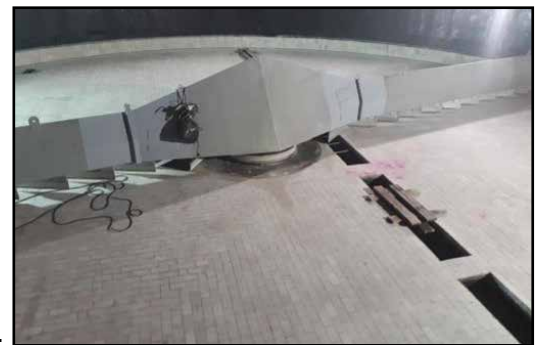
2.

Corrosion of concrete and surface due to the scraper moving the granules around the area.
