BELZONA SUPERWRAP II PATCH REPAIR ON TANK

Restoration of a tank external using several composite SuperWrap II patches.

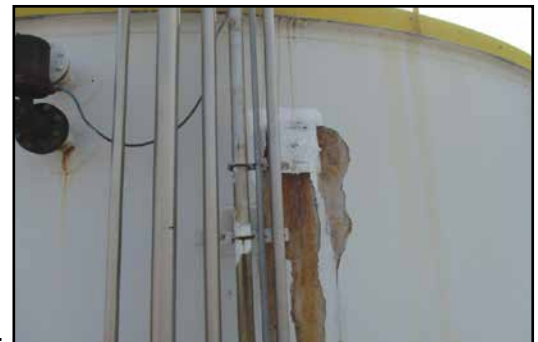
External corrosion on the exterior of a tank causing a loss in material substrate.

1. Defect zone
2. Up close of the defect zone
3. After mechanical preparation
4. Final application
