## PUMP REPAIR AND PROTECTION WITH BELZONA 1814

Rebuilding and protecting a pump for a shipyard.

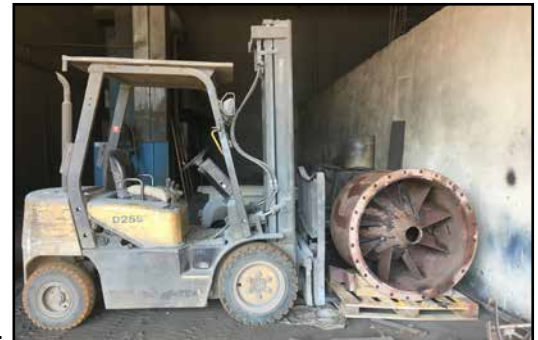
The pump was suffering from corrosion and also abrasion/erosion from the entrained solids within the process, this was causing a loss in pump efficiency.

1. Before application
2. Rebuilding body of the pump with Belzona 1814
3. Rebuilding pump vanes with Belzona 1814, other sections rebuilt with Belzona 1311
4. Final application - 2 coats of Belzona 1321
