BELZONA HELPS IN THE RESTORATION OF AN IRRIGATION PIPELINE

Restoring an old irrigation pipeline within a pumping station.

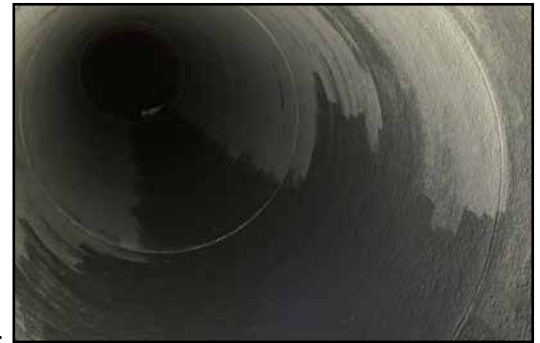
1. View after sandblasting
2. Application of Belzona 1121
3. Application of Belzona 1982/9381
4. Application of Belzona 5821

This application was carried out in accordance with system leaflet TCC-05. The internal walls of the pipeline were sandblasted and then any pitted areas were filled in with Belzona 1121. A Belzona SW2 system was then fabricated to create a "pipe within a pipe" to restore the existing pipeline. Finally 2 coats of Belzona 5821 was applied over the SW2 system to provide corrosion and erosion resistance.
