## BELZONA RESTORES INTERNAL TANK WALL AGAINST CORROSION

Repair of a steel tank (980 m<sup>3</sup>) used to store a mixture of salt water and oil.

The tank was suffering from severe internal pitting and corrosion.

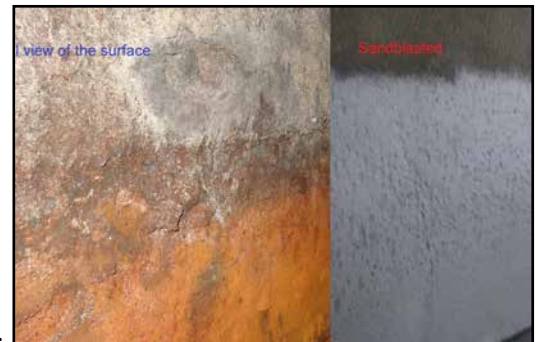
1. Initial view of the corroded tank wall
2. Wall thickness restoration
3. Stripe coating weld seams and plate bonding
4. The finished application of Belzona 5892 Corrosion protection
