## BELZONA PNEUMATIC RUBBER FENDER REPAIR

Aban Offshore Ltd. Navi Mumbai, India

October 2019

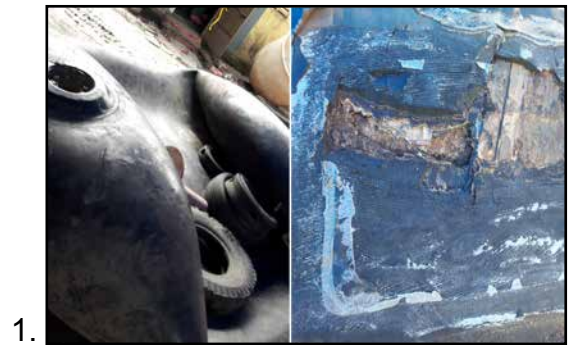
The Aban offshore company sent a fender which was being used to protect rig platform legs & they had become worn and punctured over time.

Fenders were wrapped with tyres & chains for additional protection, which damages the fender & it become worn & punctured. Hence they were in need of a full service or replacement.

1. Deflated Fender & Punctured Area
2. Surface Prepared & Conditioning
3. Application With 2211 & 9341
4. Finished Application
