## BELZONA LINES INTERNALS OF A GAS MAIN

Steel Works, East Midlands, UK

Phase 5 lining of 96" site Gas main.

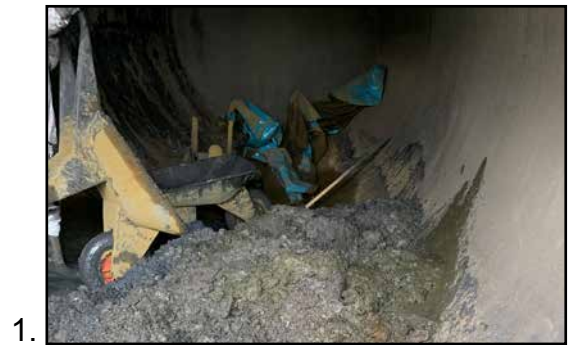
1. Residue to be removed
2. Grit Blasting
3. Pits filled with Belzona 4154
4. Finished Application

The main was cleared of residue that built up over the years. The whole pipe was cleaned and blasted to an SA 2.5, 75 micron profile, ready for the Belzona application. Any holes are over plated using 150mm<sup>2</sup> plates, bonded in position with Belzona 1151. The heavily pitted areas are filled with Belzona 4154 bulk fill material. The mix was achieved using 2 x units of resin to one bag of kiln-dried sand. Two coats of Belzona 5811 were spray applied to a total of 1000µm thickness in order to provide corrosion protection. This was applied in accordance with Belzona System Leaflet VPF-01. Application from start to finish took 4 days.
