## BELZONA SUPERWRAP II USED FOR A PIPE REPAIR

Petrochemical company, Slovakia

Underground pipe had developed thin-wall defect.

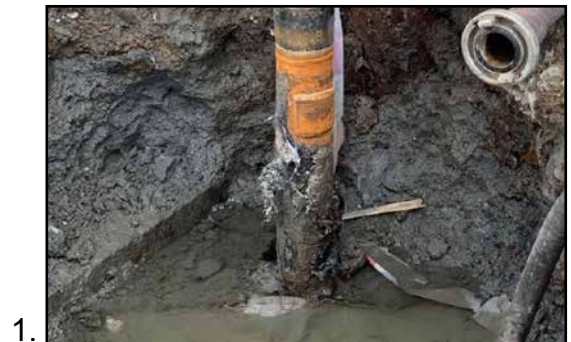
The customer recorded water leakage in system. Underground pipe had developed thin-wall defect. They tried to weld this damaged place several times. On the thin wall they found permanently new damages (also like thermal influence from welding)

1. Underground pipe had developed thin-wall defect
2. The surface was blasted to the 75 microns profile and cleanliness Sa 2,5
3. All system then was wrapped to Belzona 9382
4. Super Wrap II ready for use
