BELZONA REPAIRS THE CLINKER CRUSHER ROTOR

Cement producer, Slovakia

2020

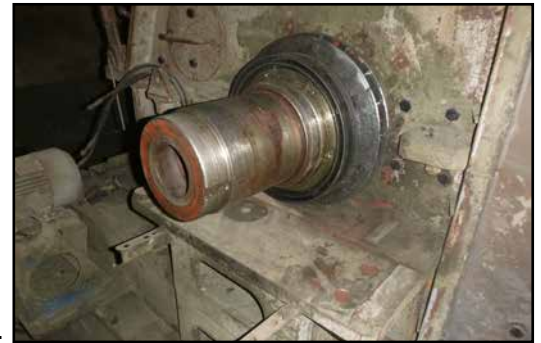
The crusher rotor was damaged due to the loading and working environment.

1. Damaged rotor
2. Rotor after machining, preparing for Belzona 1111 application
3. Belzona 1111 machined
4. The rotor prepared for operation
