## BELZONA 2311 REPAIRS WASTE INCINERATION PLANT CONVEYOR BELT

**CUSTOMER**  
Switzerland

**APPLICATION DATE**  
June, 2019

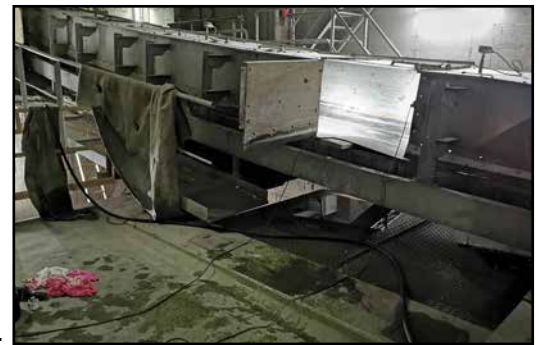
A conveyor belt had torn during operation within a waste incineration plant. Conveyor belts transport biomass from the waste heap to shredders or transfer stations.

1. Conveyor System
2. Conveyor Belt Tear
3. Belzona 2311
4. Application Complete

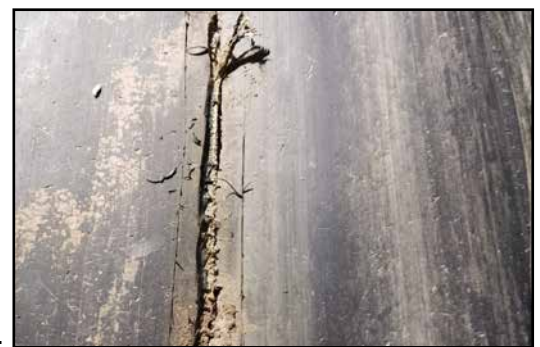
2.

There were a number of tears in the conveyor belts due to the medium that was being transported along the conveyors. If the belts had torn completely the waste would have spread all over the internal of the operation and also the whole plant would have to be shut down to repair.
